**IN THE UNITED STATES DISTRICT COURT
FOR THE SOUTHERN DISTRICT OF TEXAS
HOUSTON DIVISION**

**C.A. NO. 4:18-cv-3113
RULE 9(h) - ADMIRALTY**

FINDINGS OF FACT AND CONCLUSIONS OF LAW-

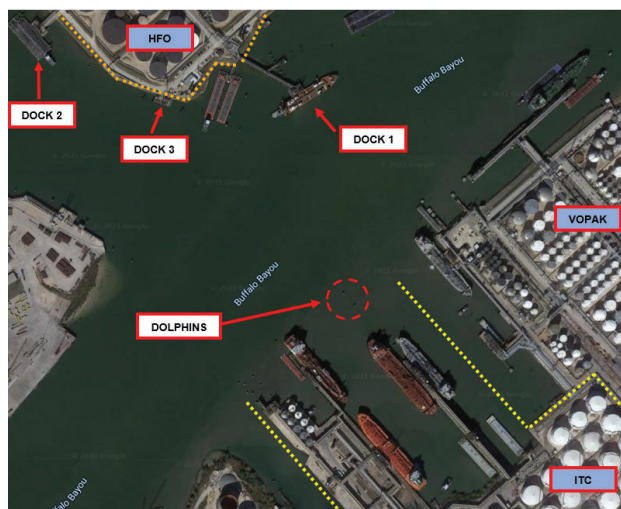
2. Intercontinental Terminals Company (“ITC”) operates a large tank facility located on the south side of the Channel across from HFO. ITC owns two monopile mooring dolphins there named 78A and 78B (the “Dolphins”), which are located outside the southern limits of the federally-designated Channel lane. ITC was the original plaintiff in this action, but it eventually settled its claim with Aframax River Marine Co. (“ARM”) prior to trial.
3. A Google map of the area at issue is included below, for general reference. HFO’s facility (on the north side of the Channel) is designated with an orange border. The ITC and Vopak facilities (on the south side of the Channel) are demarcated with a yellow border.

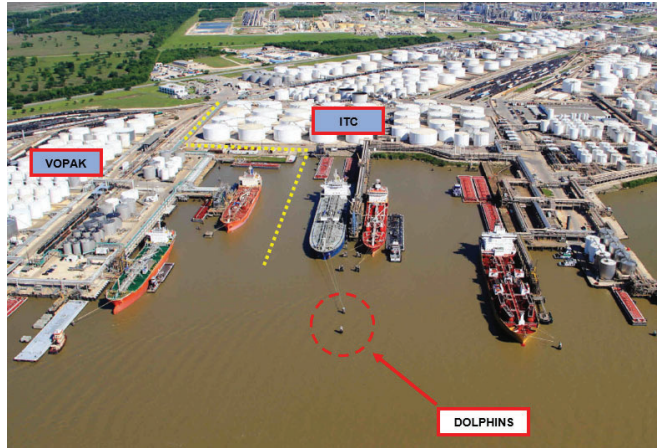
4. The exemplary photo below separately depicts the Dolphins looking S/SE from HFO:

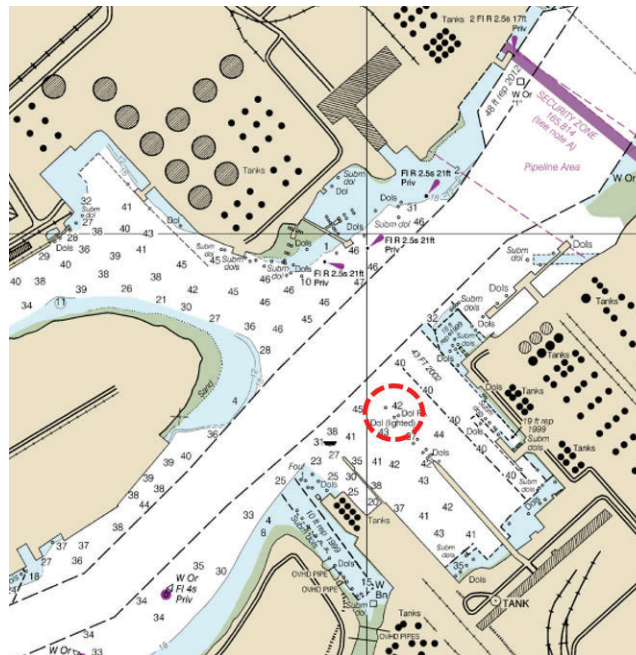
5. The Dolphins are also clearly marked on the official navigational chart for the Channel, and can be seen positioned outside the dashed-limits of the Channel's navigational lane, as follows :
